# California State Insectary

HISTORIC AMERICAN BUILDINGS SURVEY  
LYN HOOPER

CALIFORNIA STATE INSECTARY  
(Capitol Park Insectary)

HABS No. CA-XXXX

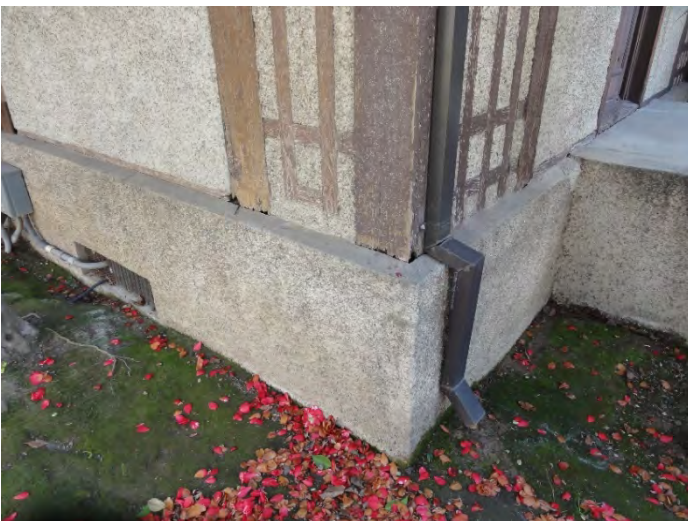
The concrete foundation is generally in good condition, but there are limited areas, particularly around the removed basement stair, where the concrete is crumbling due to water intrusion. Generally, the water damage appears to stem from the detailing of the untreated exposed redwood sill plates. These plates lay flat on the top of the footing without flashing or a way to drain water that accumulates on the ledge or weeps down through the inside of the wall. These sills are in poor condition around the entire perimeter of the building.

Figure 11: Northwest corner of the building showing perimeter concrete foundation

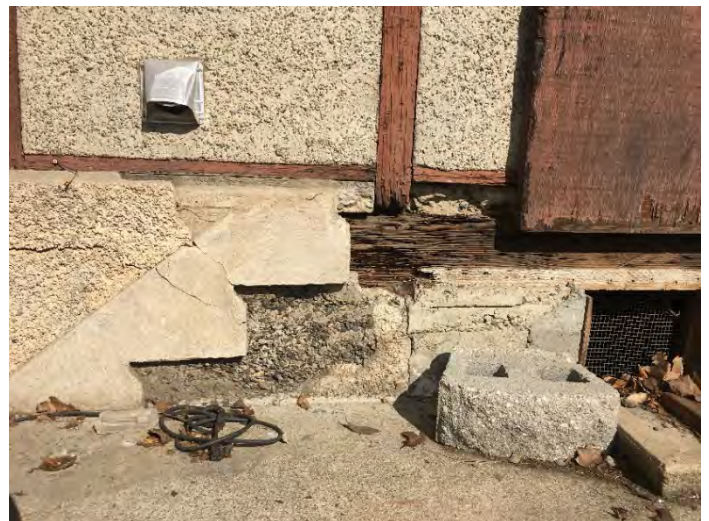
Figure 12: Deteriorated sill plate at former basement stair location.

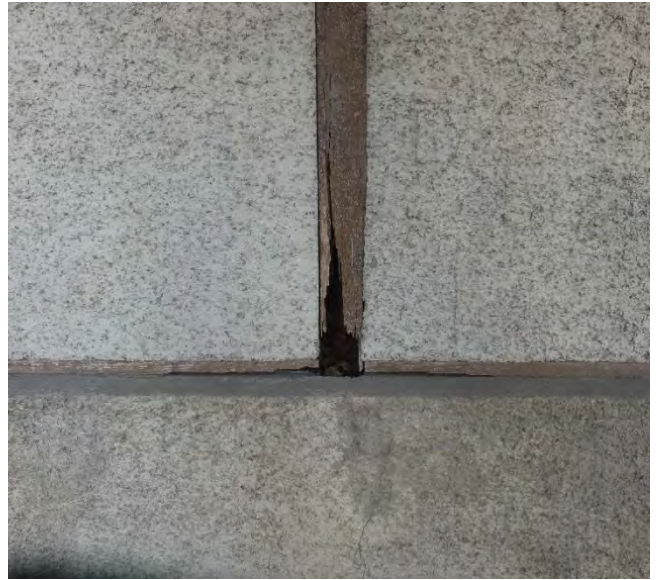
The building is of post and beam construction on a rough cast raised concrete perimeter foundation. The exterior finish of the walls is a mix of exposed redwood posts and beams and 1/2" thick rough cast cement plaster with redwood trim. The redwood posts are recessed into the perimeter foundation, allowing for water damage at the base of many of the posts.

Figure 16: Base of redwood post and sill are damaged from dry rot

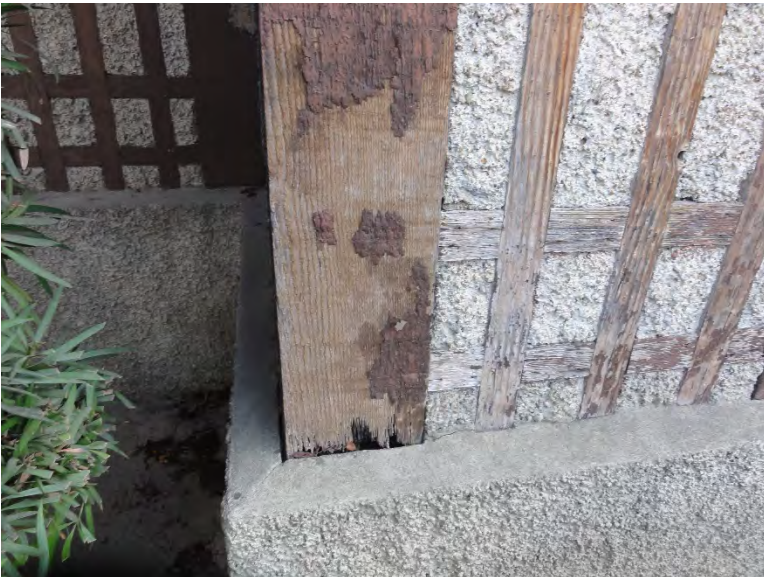
All exterior redwood was painted. Much of the paint is damaged or missing at the base of the west and north walls due to routine exposure to irrigation sprinklers.

Figure 17: Base of redwood post showing water damage

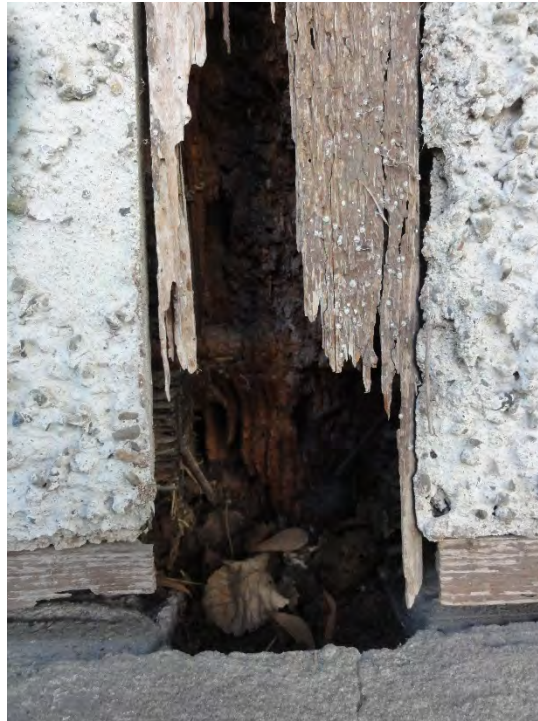
Several of the structural redwood posts are in poor condition. These posts are no longer serving their structural purpose due to dry rotted bases, which are the result of moisture intrusion. It is likely that routine exposure to landscape sprinklers has accelerated this damage. A structural assessment should be conducted to determine if the building is safe for human habitation.

*Figure 19: Base of redwood post is entirely rotted*

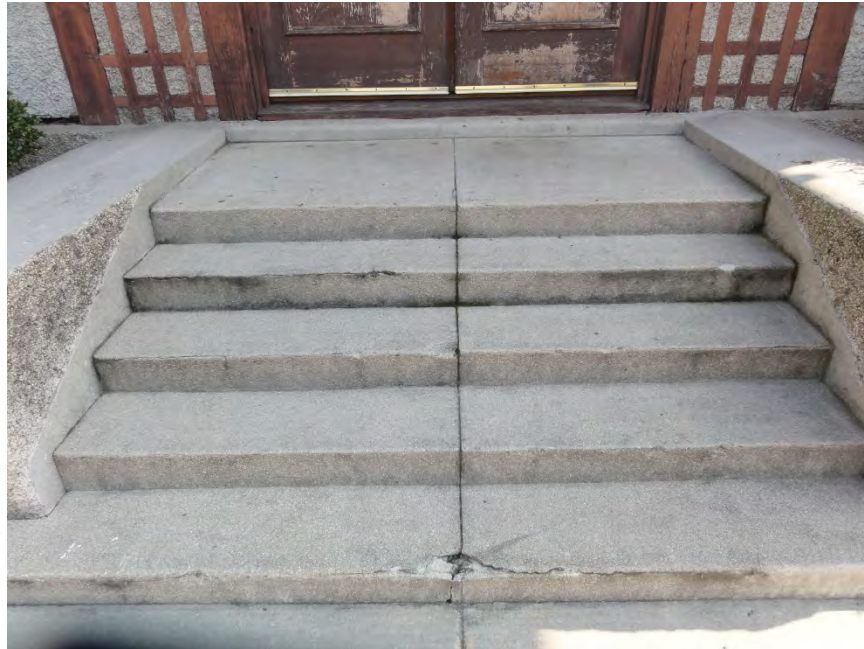
The stoops are in good condition; although, there is some wear and tear from ordinary use and water intrusion damage at the risers and treads causing limited spalling. The northern stoop has a painted pipe handrail that was installed sometime after the completion of the 1938 alteration.

Figure 20: Stoop at main entry

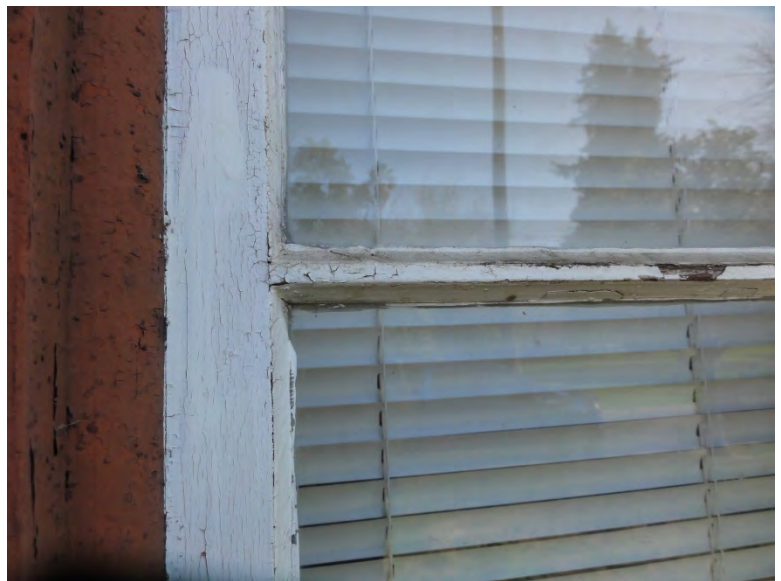
Figure 31: Detailed view of west facing window shows crazed and failing paint at the sash and muntin

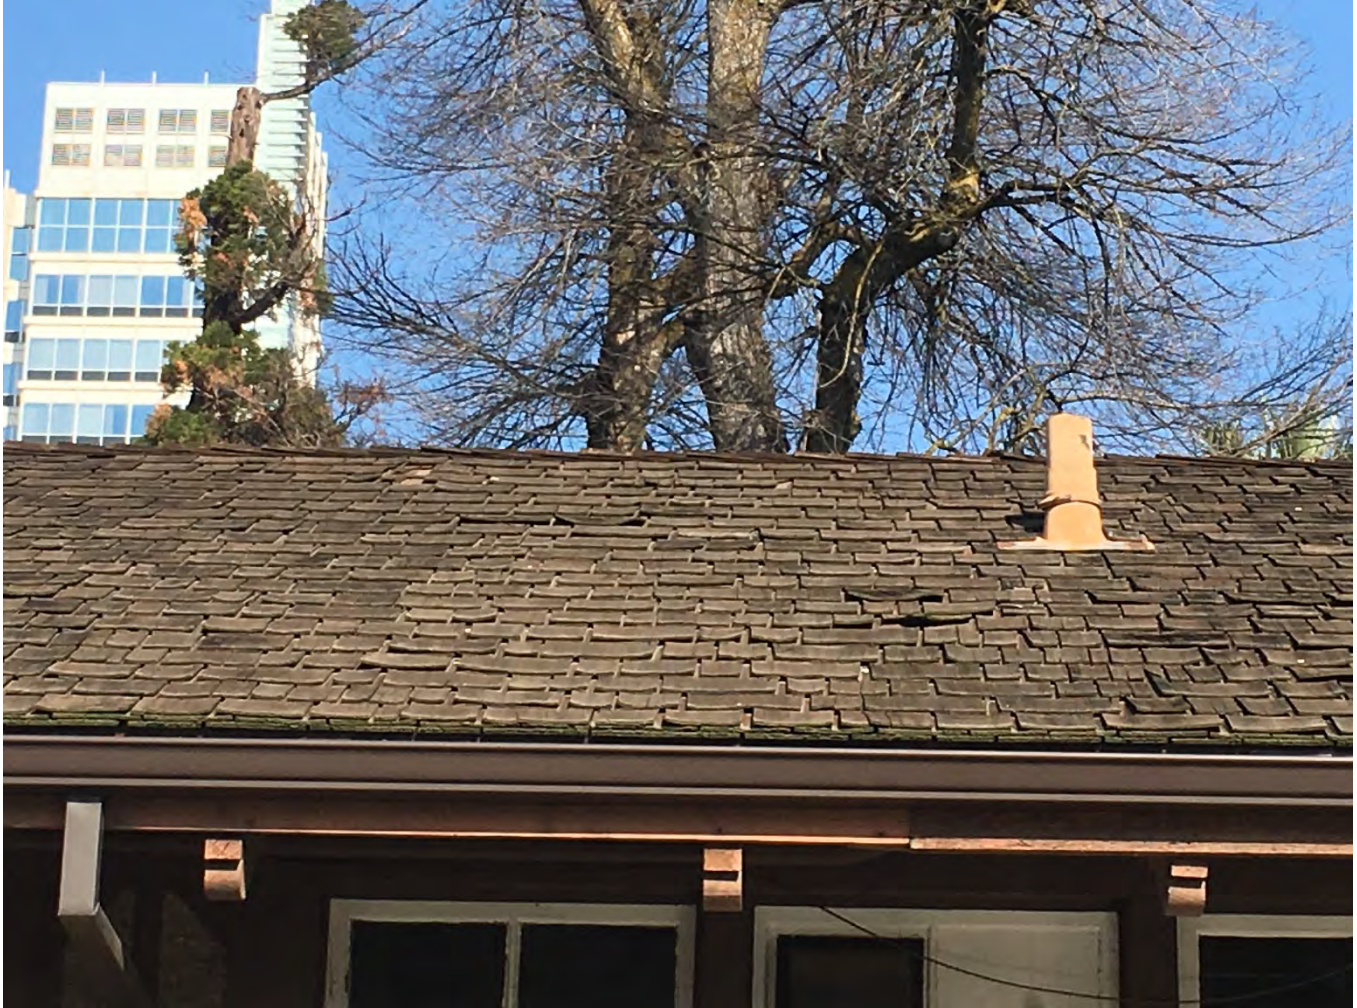
The hip roof is finished in redwood shingles. A reroof project was completed in 2001, at which time plywood sheathing was installed over existing skip sheathing. Cupping is beginning to occur on some of the shingles, which will ultimately lead to leaks if the roof is not replaced.

*Figure 39: Close up view of shingle roof showing cupping*

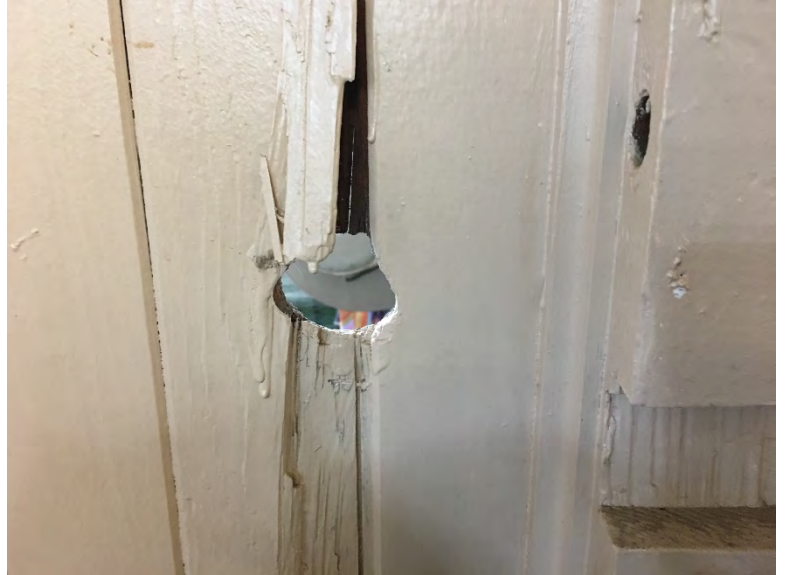
*Figure 57: Tongue and groove partitions are one layer thick as this damaged partition indicates. The courtyard is visible through the hole.*

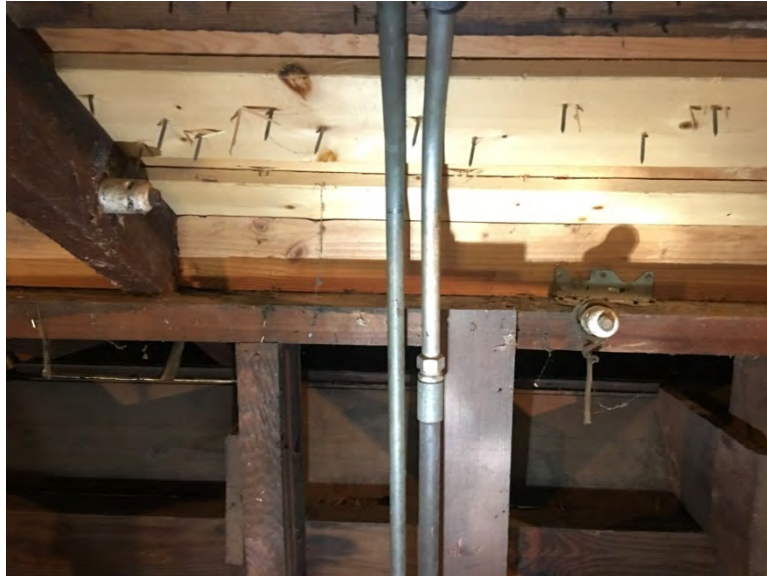
The building originally had an electrical distribution system consisting of knob and tube wiring; the remnants can be seen still in the attic:

*Figure 105: Abandoned knob and tube wiring still evident in the attic*
