# California State Insectary

HISTORIC AMERICAN BUILDINGS SURVEY  
LYN HOOPER

CALIFORNIA STATE INSECTARY  
(Capitol Park Insectary)

HABS No. CA-XXXX

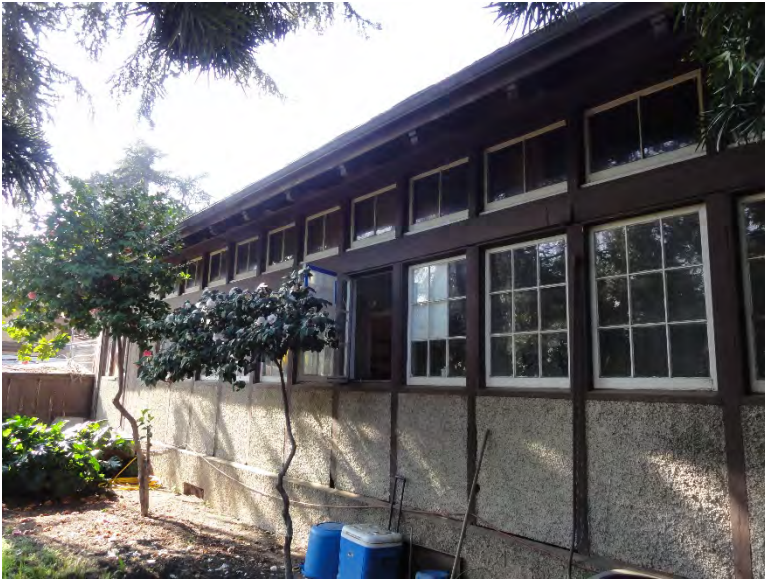
The building is of post and beam construction on a rough cast raised concrete perimeter foundation. The exterior finish of the walls is a mix of exposed redwood posts and beams and 1/2" thick rough cast cement plaster with redwood trim. The redwood posts are recessed into the perimeter foundation, allowing for water damage at the base of many of the posts.

All exterior redwood was painted. Much of the paint is damaged or missing at the base of the west and north walls due to routine exposure to irrigation sprinklers.

Figure 15: Rear (east) facade showing exposed posts extending from foundation to roof with windows and cement plaster panels in between.

Several of the structural redwood posts are in poor condition. These posts are no longer serving their structural purpose due to dry rotted bases, which are the result of moisture intrusion. It is likely that routine exposure to landscape sprinklers has accelerated this damage. A structural assessment should be conducted to determine if the building is safe for human habitation.

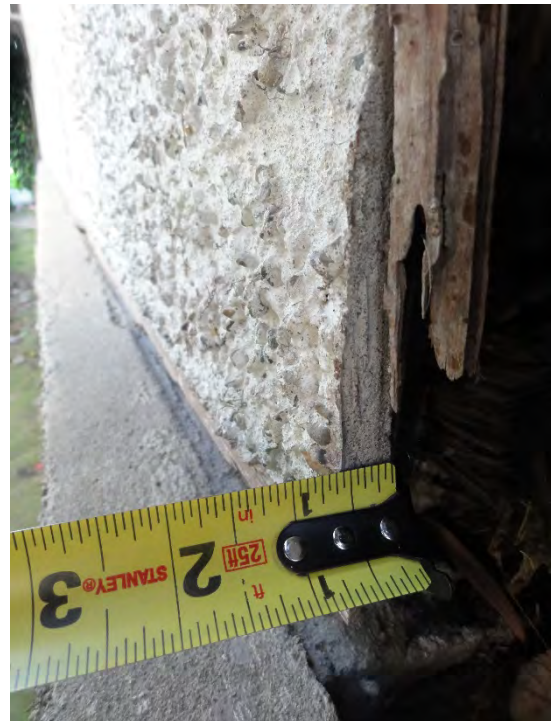
Figure 18: Thickness of exterior cement plaster panels

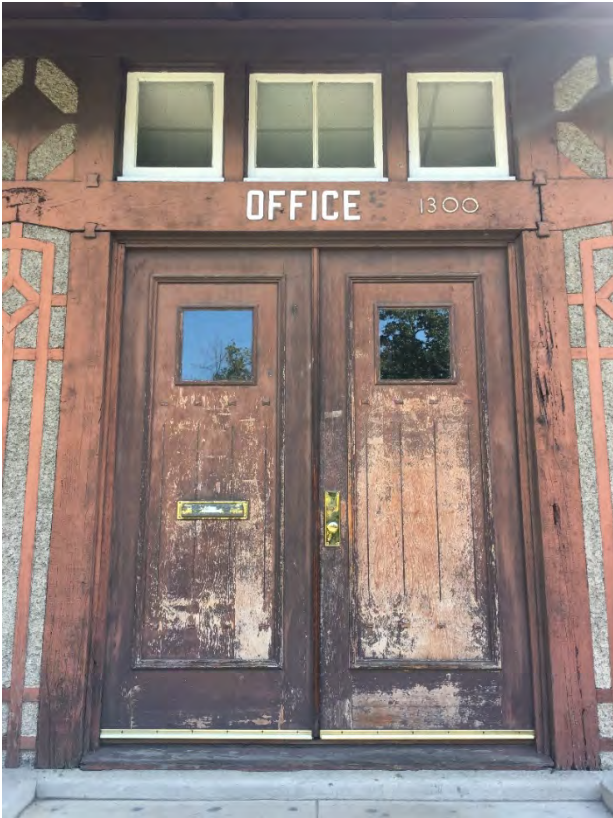
Figure 23: Exterior of original main entry doors

All original doors are in good condition; however, exterior surfaces need paint.

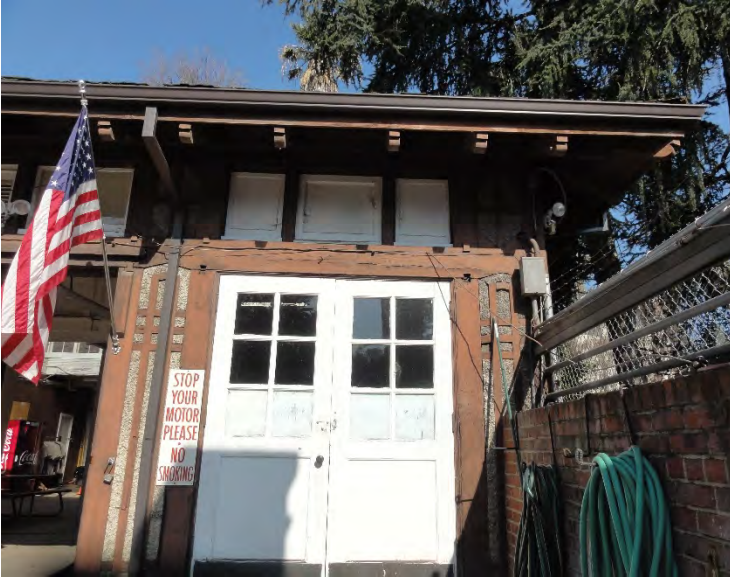
Additionally, the drawing references a new and existing ramp up to these doors. The ramps still exist and are very steep. The ramp on the left in the detail has a slope of 14.2%, while the slope on the right is 25.5%. By comparison, accessible slopes for pedestrian use are a maximum of 5% without a handrail and 8.33% with a handrail.

Figure 28: Exterior view of 1938 door type 5 as originally installed

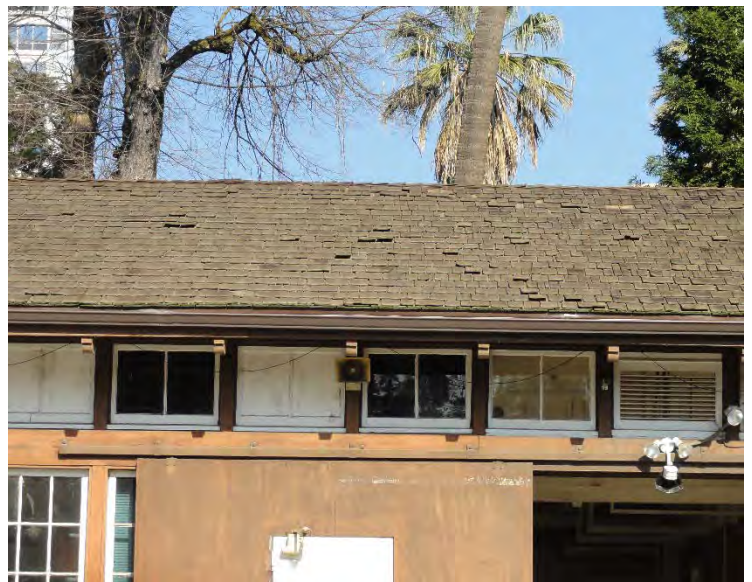
Figure 35: Three original hopper windows, two modified with painted glass and one with a louvered vent

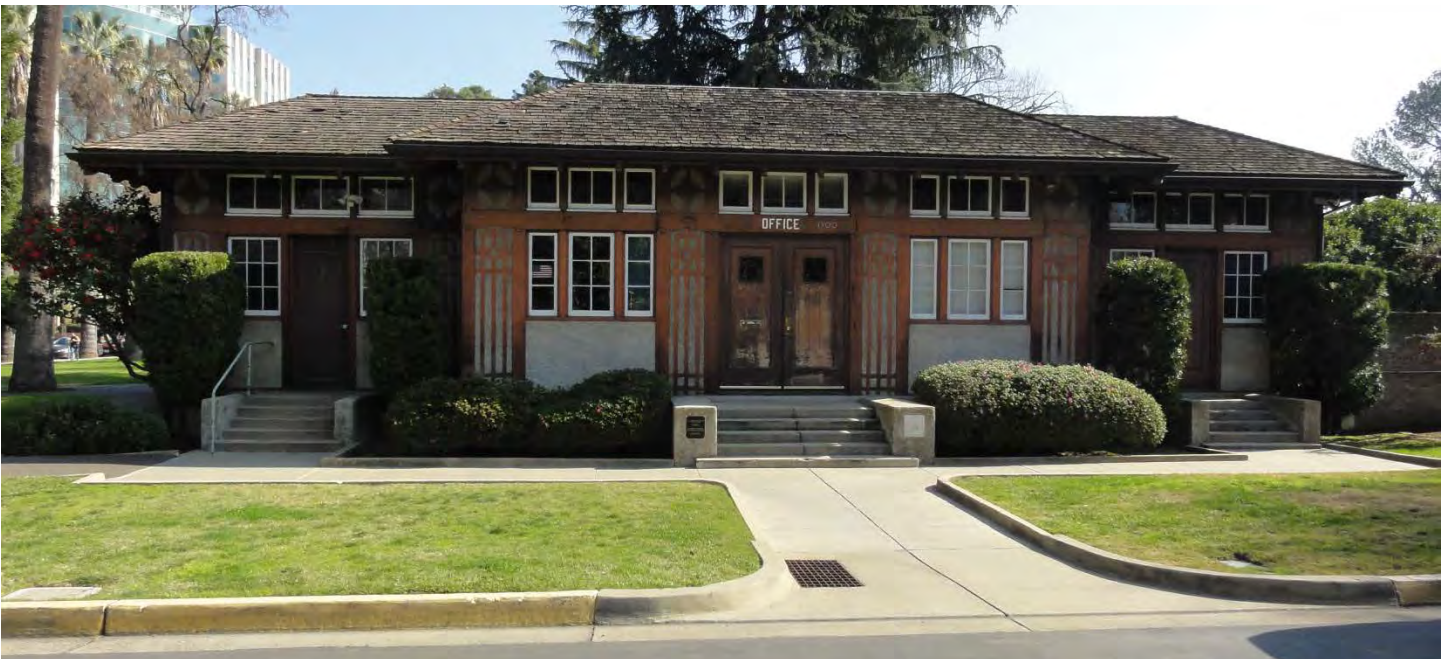
Figure 38: View of the west facade showing the hip roof

The hip roof is finished in redwood shingles. A reroof project was completed in 2001, at which time plywood sheathing was installed over existing skip sheathing. Cupping is beginning to occur on some of the shingles, which will ultimately lead to leaks if the roof is not replaced.

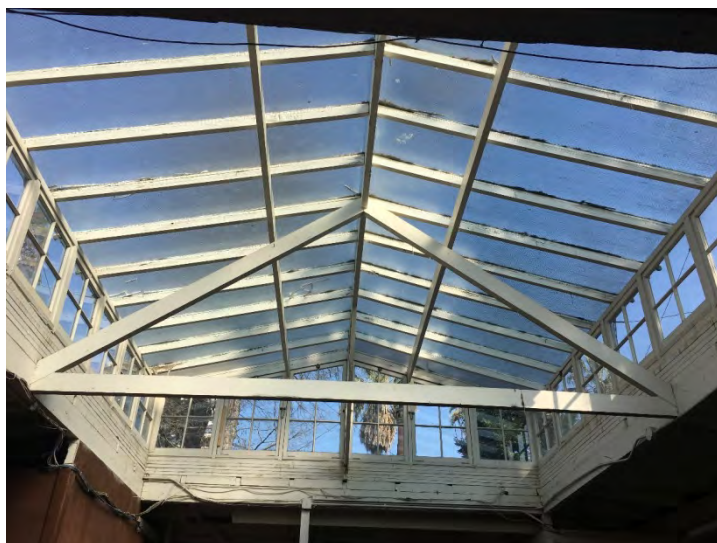
The original skylight was either altered from its original design or replaced at some point to its current configuration. The drawings indicate that the skylight glazing was to cover the entire area of the courtyard, however, today only the center portion of the structure is glazing. The rest of the roofing is a low sloping hip roof of 2x framing with a roughly 10'-5" by 15'-9" gable skylight structure rising above the center of the courtyard. The skylight glazing is very old glass, including wire glass at the sloped surfaces. The 1938 drawings call for the skylight glass to be repaired; therefore, if the glass is not original to the 1913 skylight, it may have been replaced with the 1938 remodel.

Figure 41: Skylight

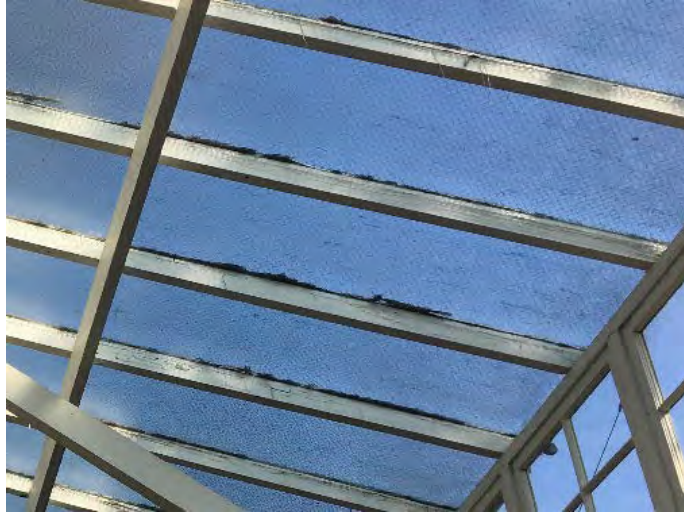
Figure 43: Enlarged view of wire glass at skylight

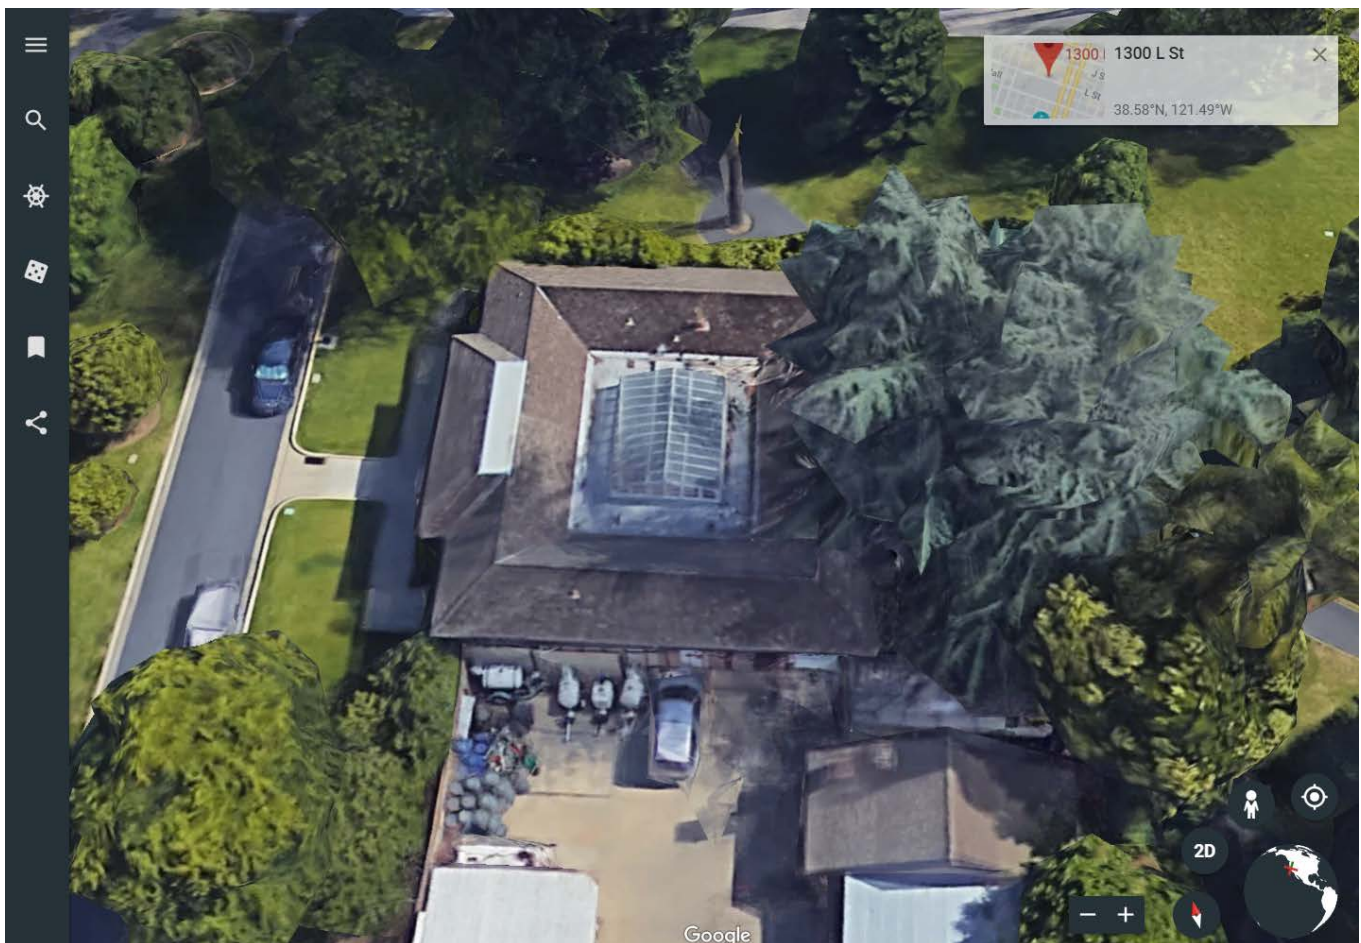
Figure 44: Google Earth image showing existing roof and skylight configuration<sup>41</sup>

The 2001 reroof did not include any information about the roofing material over the wood framed portion of the skylight structure or the flat portion of the hip roofed entry. It is assumption that it is finished in single ply roofing, typical of most flatter roof state owned projects. A view from Google Earth appears to reinforce this assumption.

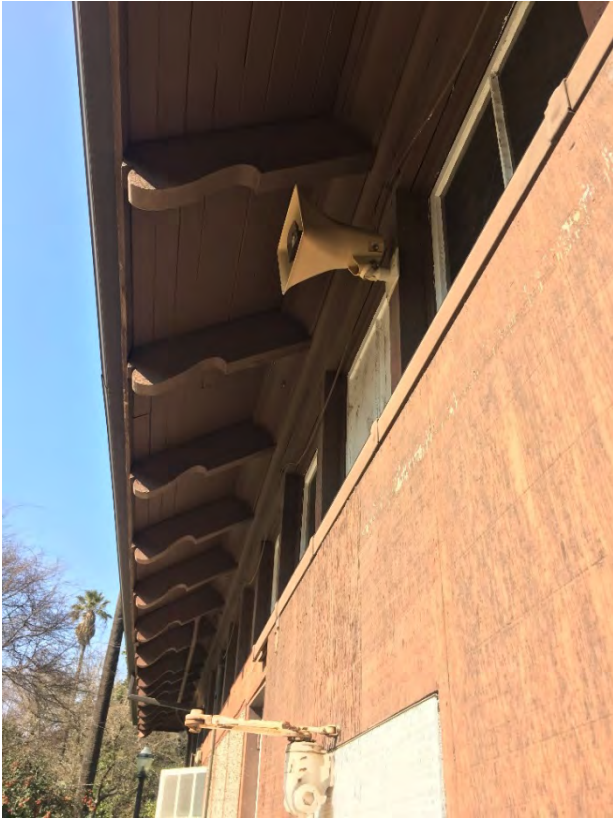
The eaves are articulated with exposed rafters with decoratively cut tails. The rafter tails are further adorned with brackets on the courtyard side. These elements are in good condition.

Figure 45: Typical exposed rafter tails at the exterior of the building

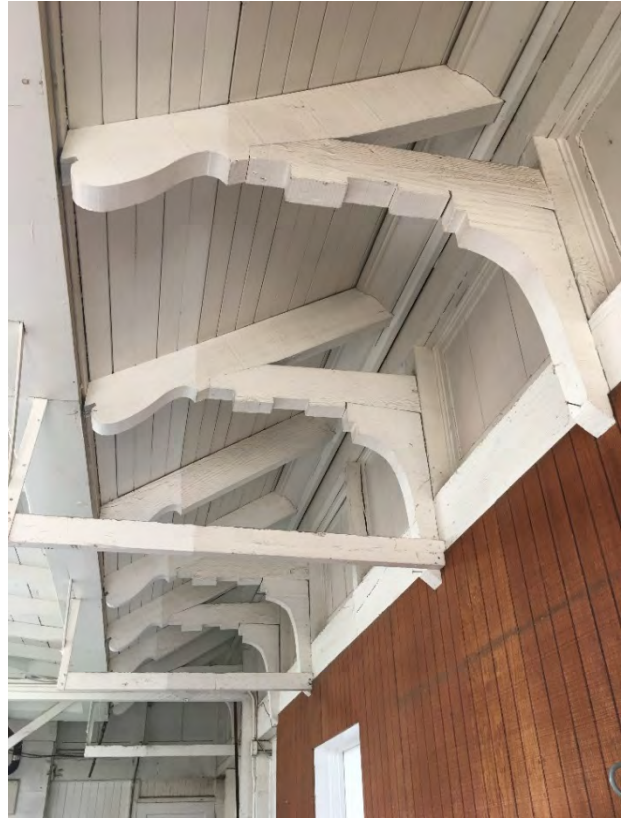
Figure 46: Typical exposed rafter tails and supporting brackets at the courtyard

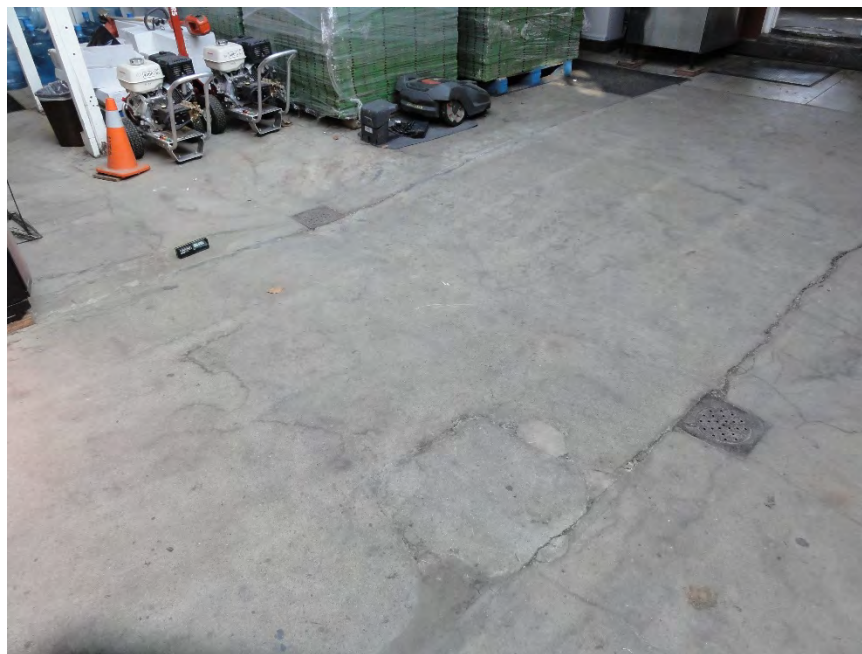
*Figure 55: Courtyard floor slab sloped to drain to original floor drains.*

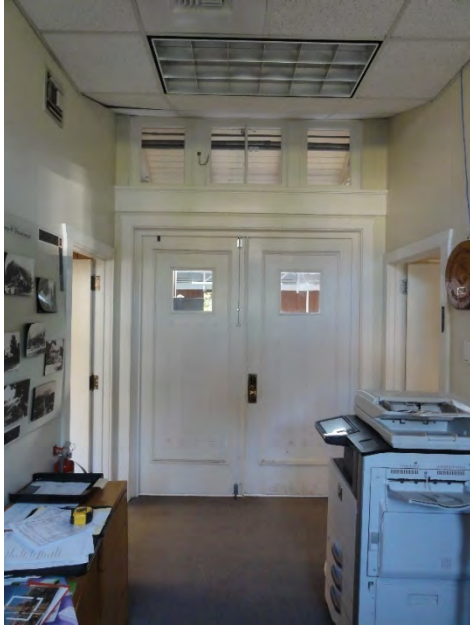
Figure 72: Doors from the original Insectary museum (lobby) to the courtyard match the main exterior entrance doors

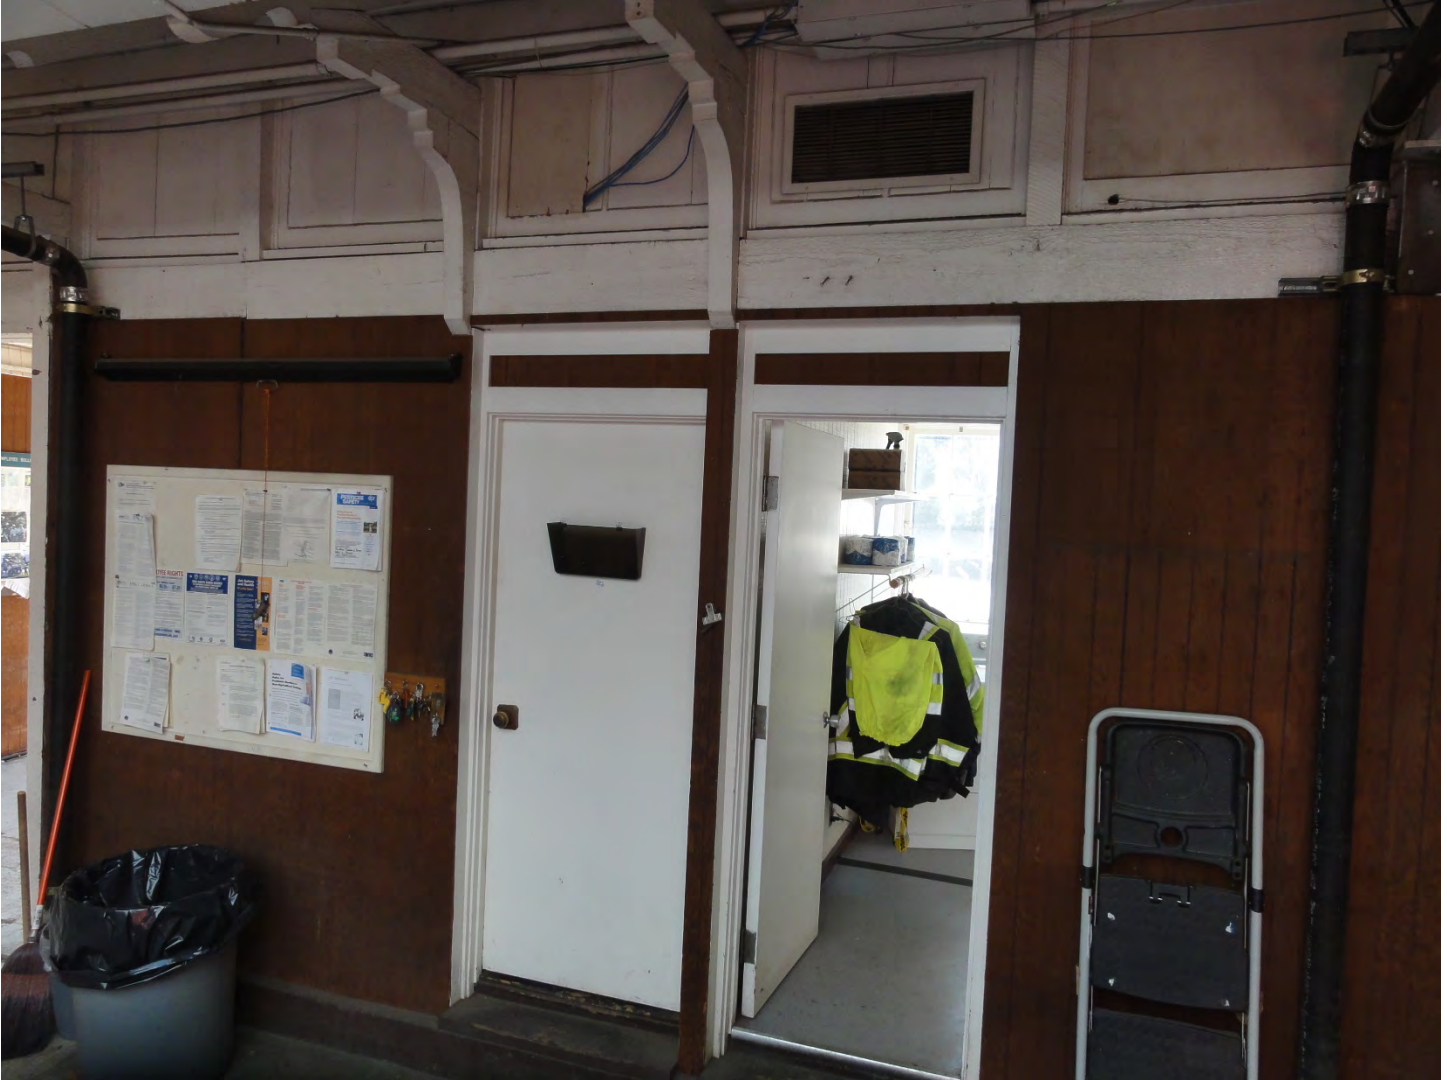
Other hardware consists of unmatched knobs, hinges and sweeps of various metals including polished brass, oil rubbed bronze and brushed nickel.

Figure 87: Two doors with mismatched hardware
